Building Conditions Survey for The Bradley Palmer Mansion

at Bradley Palmer State Park
Topsfield, Massachusetts

Prepared by
Ocmulgee Associates Consulting Structural Engineering
and
Robert Carlson
for
Commonwealth of Massachusetts
Department of Environmental Management
Historic Curatorship Program
August 1995

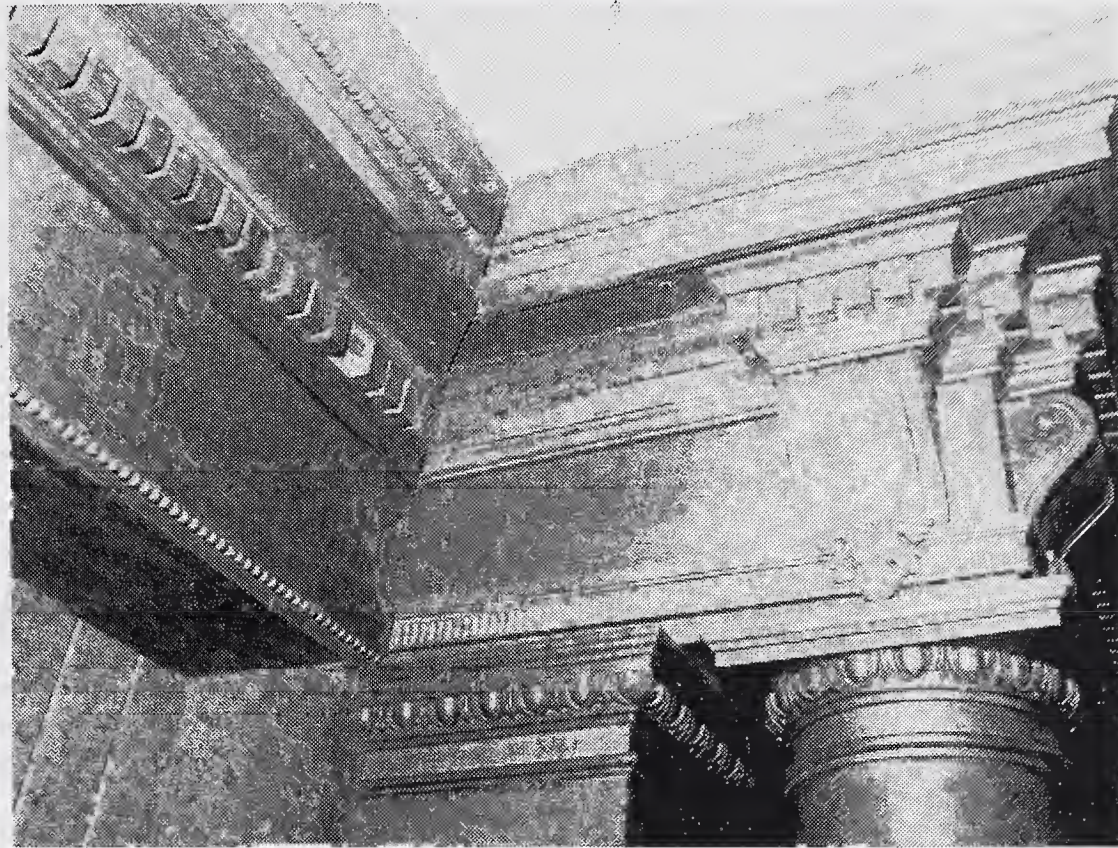
Figure 25. Missing Dentils in Cornice.

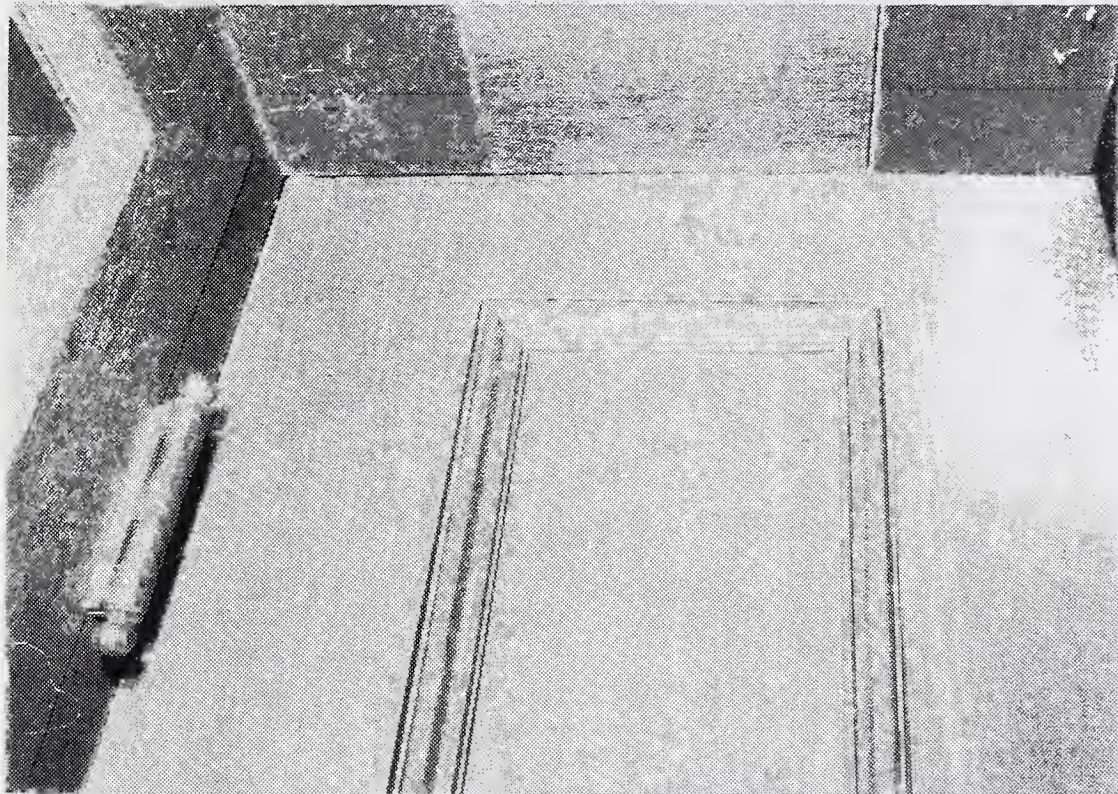
Figure 26. Waterstained Window Jamb.

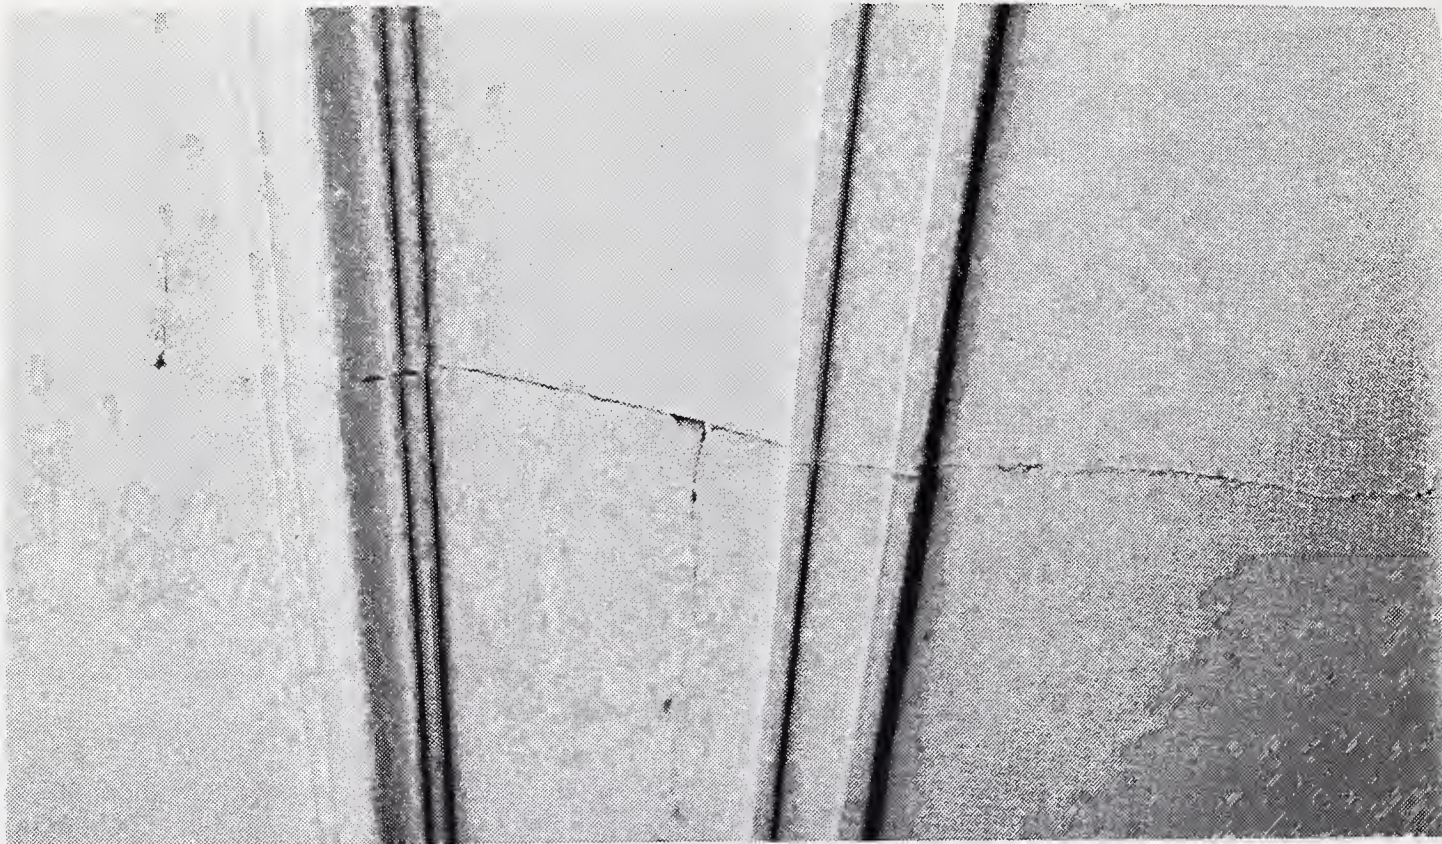
Figure 27. Typical Ceiling Cracks.

All plaster cracks should be cut back and repaired using routine modern patching methods and materials. Proper repair of cracks in the molded sections will

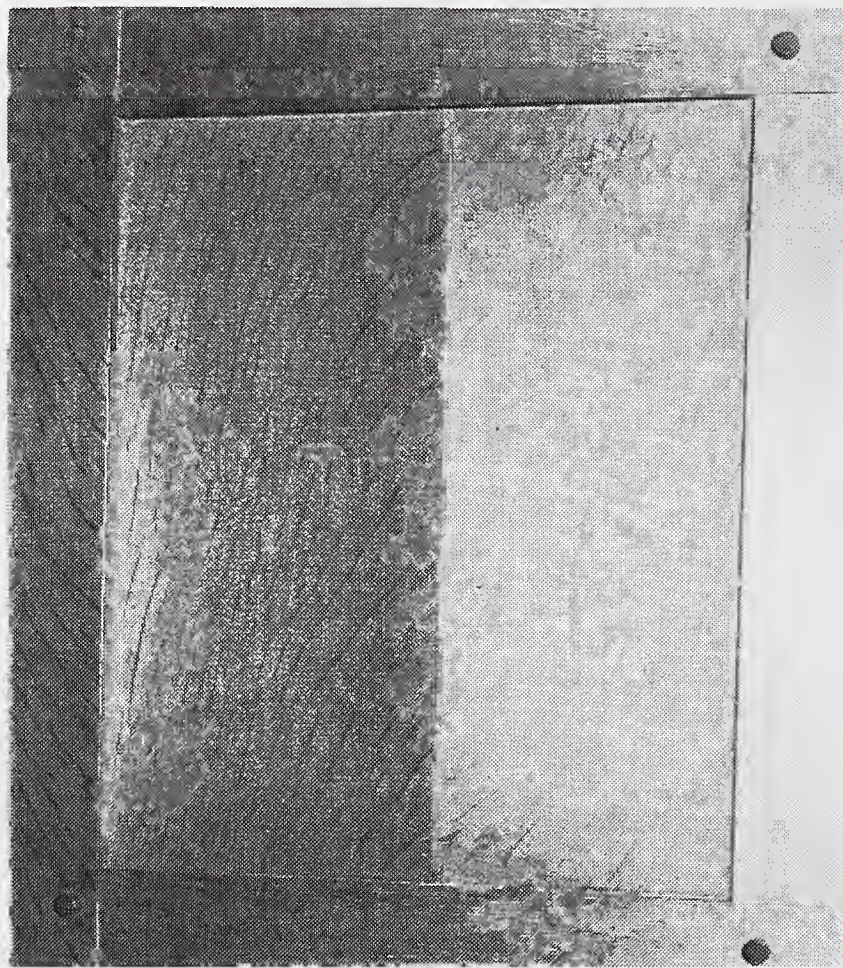
Figure 28. Quartered Oak Panel with Split at Glue Line. Note Unusual Oak Pins.

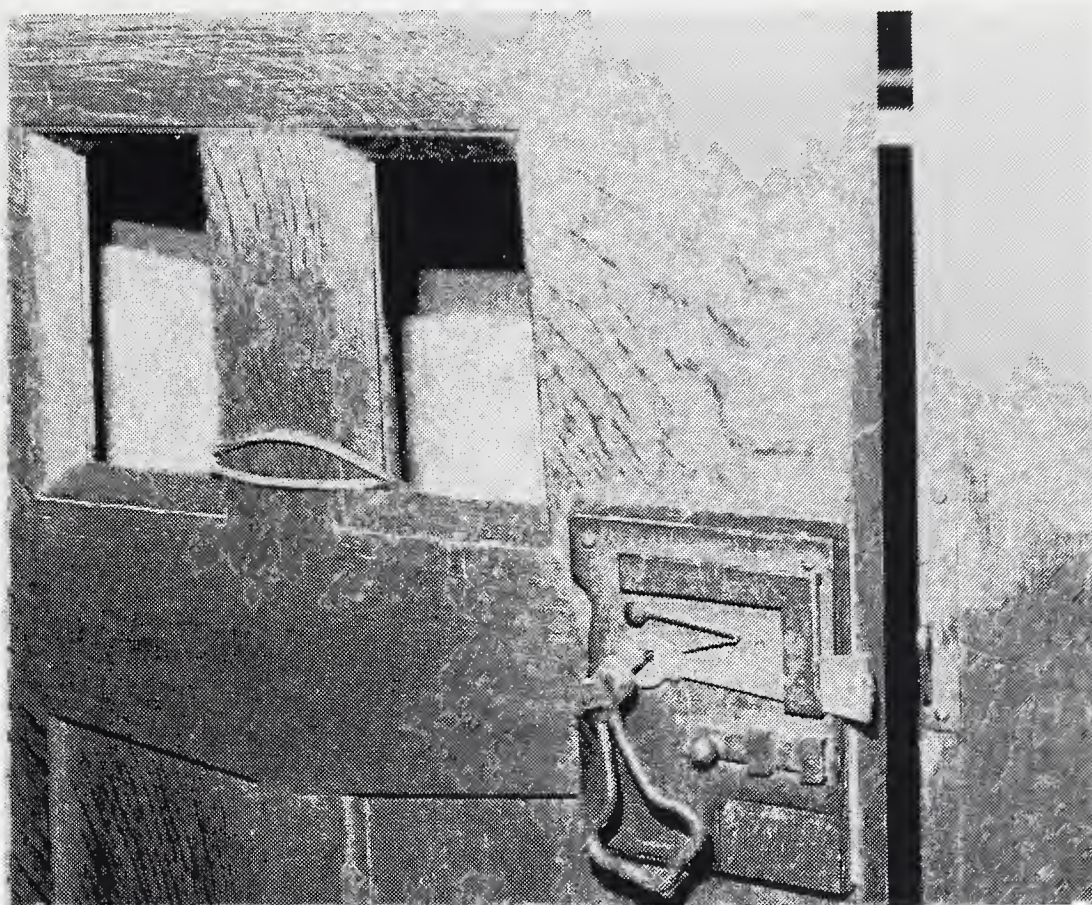
Figure 29. Closet Door with Damaged Wrought Iron Hardware and Missing Stained Glass Panels.

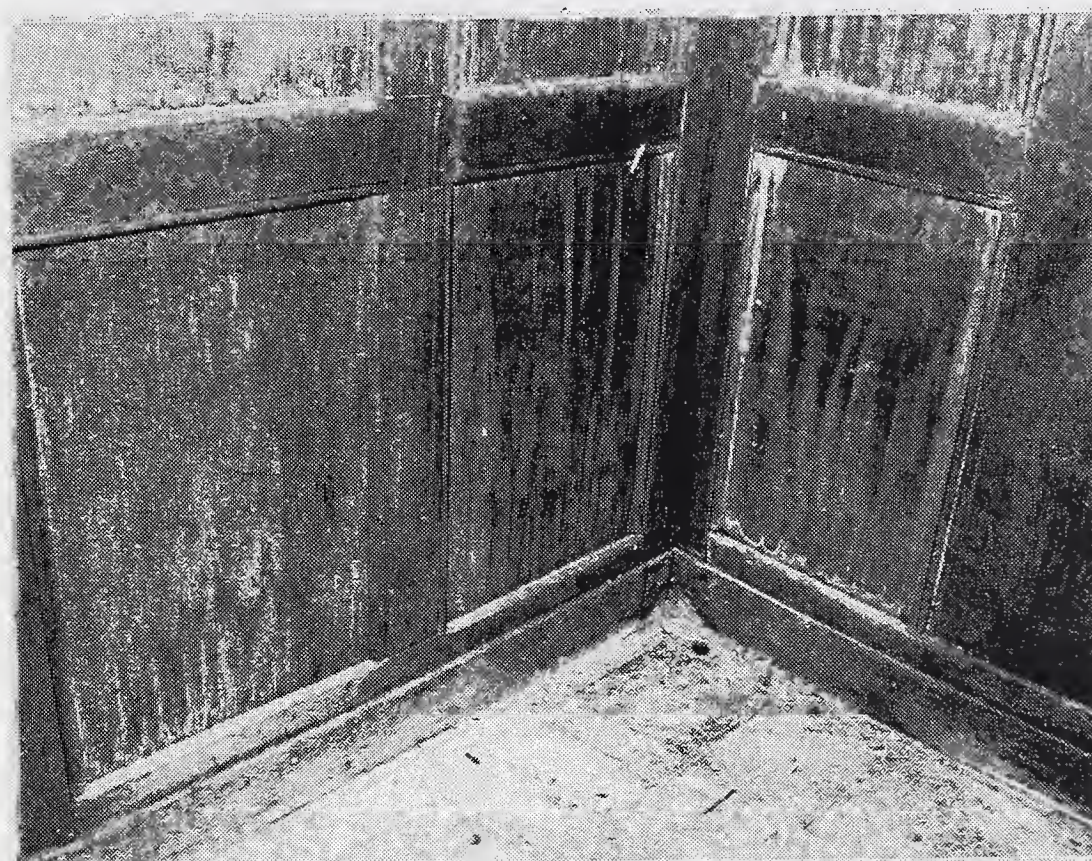
Figure 30. Severely Water Damaged Oak Veneer and Floor.

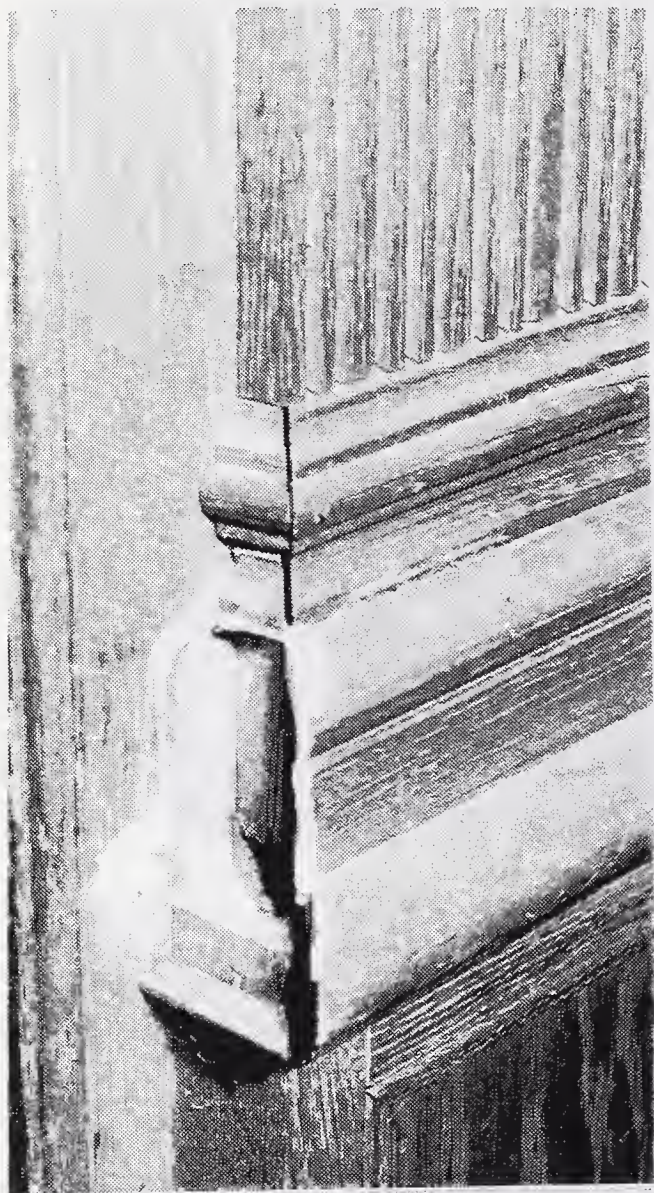
Figure 31. Typical Missing Wood Trim in Room 106.

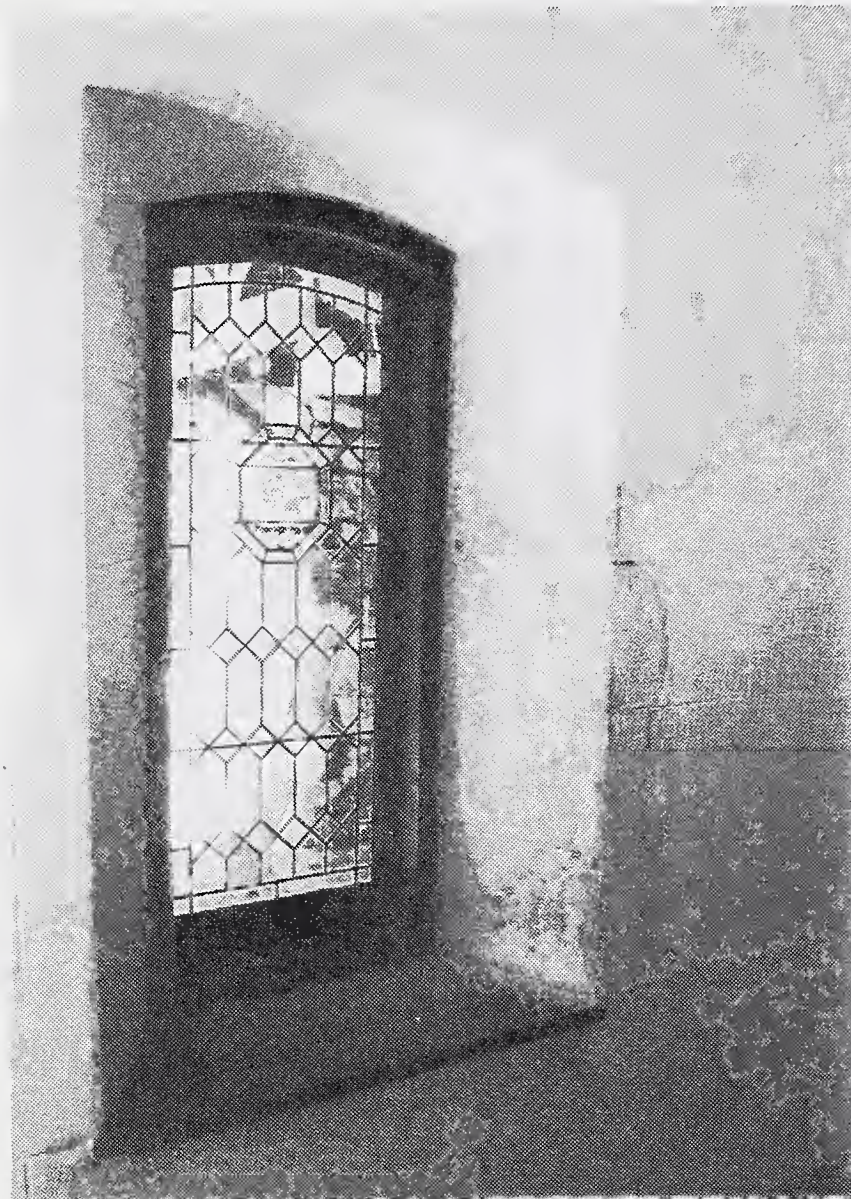
Figure 32. Water Damage to Caen Stone Plaster in Room 106A.

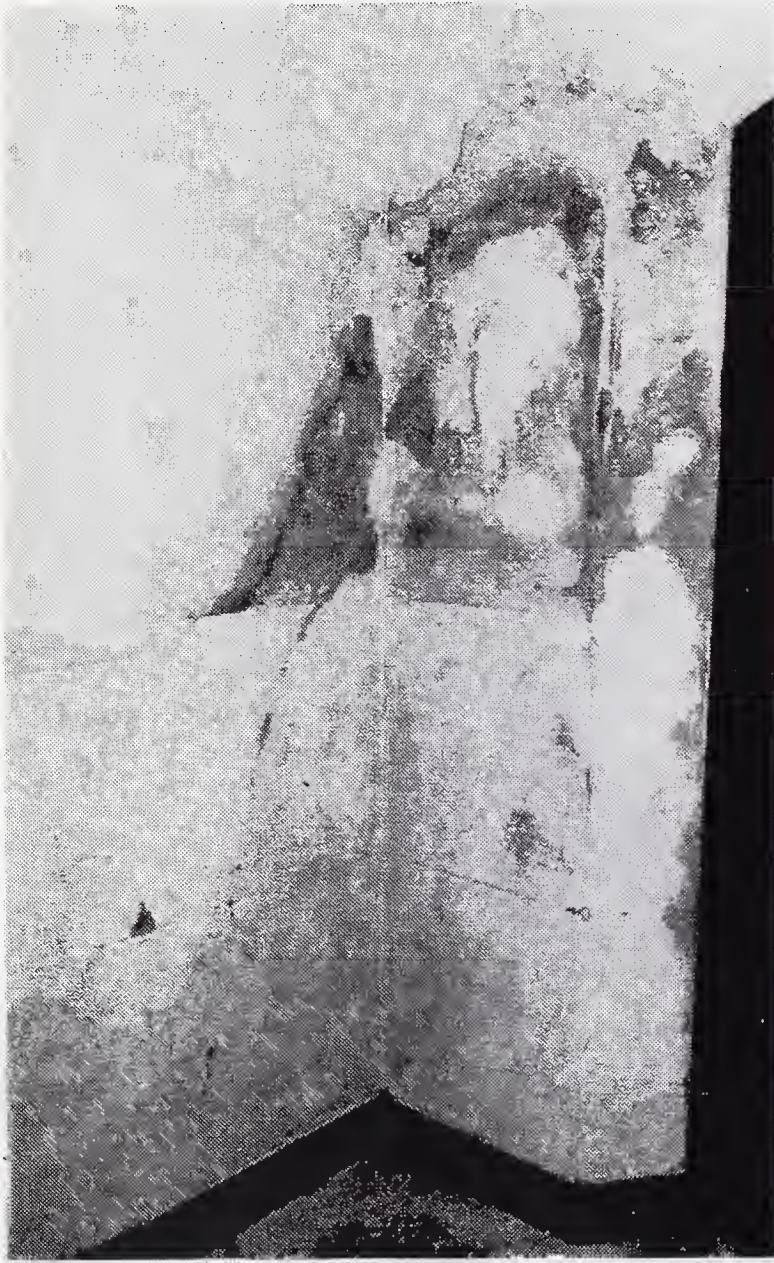
these vines are not intentionally planted native species, they should be pulled up. At the southeast corner of the dining room (room no. 110), the stonework was wet when it was observed although it hadn't rained for two or three days. This is the same location where extensive damage is visible indoors in the plasterwork. This wetness suggests, also, that the appearance of sound mortar may be deceptive, at least directly under roof valleys where concentrated streams of water can splash and wash against the stone walls. For example, defective joints on the north side of the west entry vestibule (room 106A) have caused moisture damage to the plaster inside the entry; (this is at the same location of the rotted soffit boards above the side entrance door).

Figure 33. Plaster Damage in Room 110 Due to Defective Roof Flashing and Open Masonry Joints.

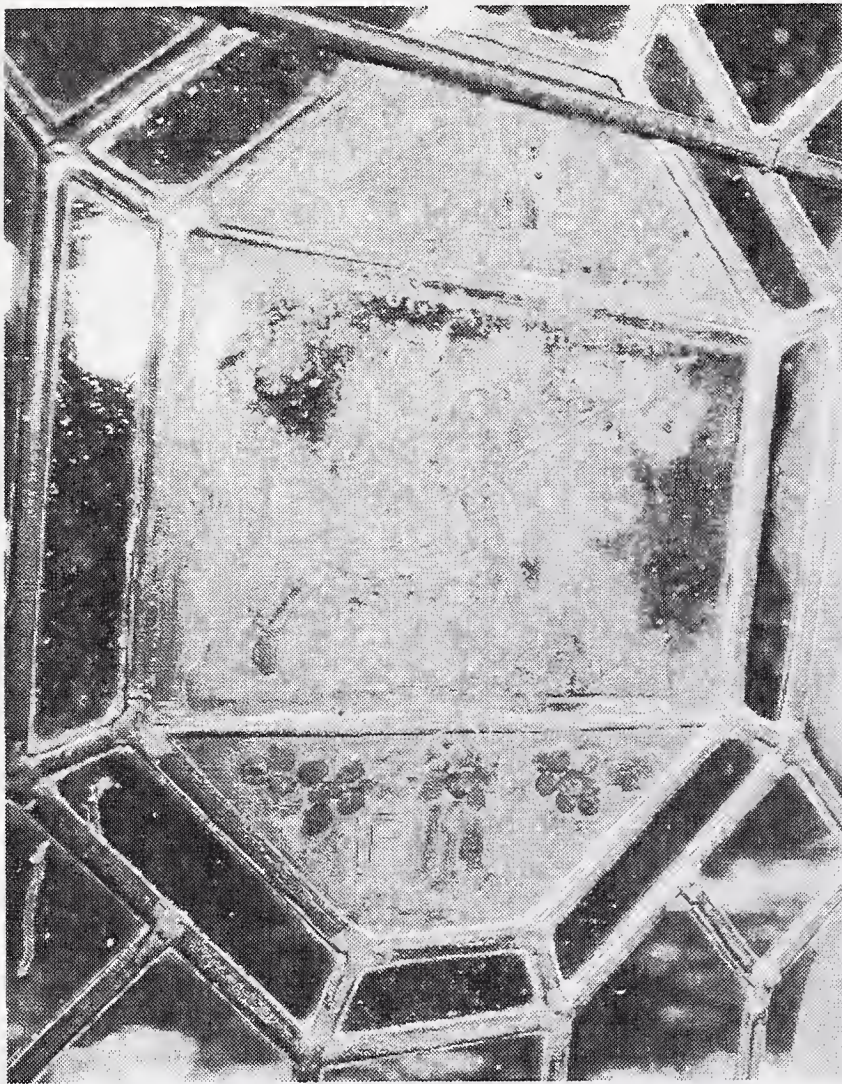
Figure 34B. Stained Glass Panel, Exterior Side Showing Imitation Patina. Note that Portions of the Patina have been Removed by Inappropriate Aggressive Cleaning.

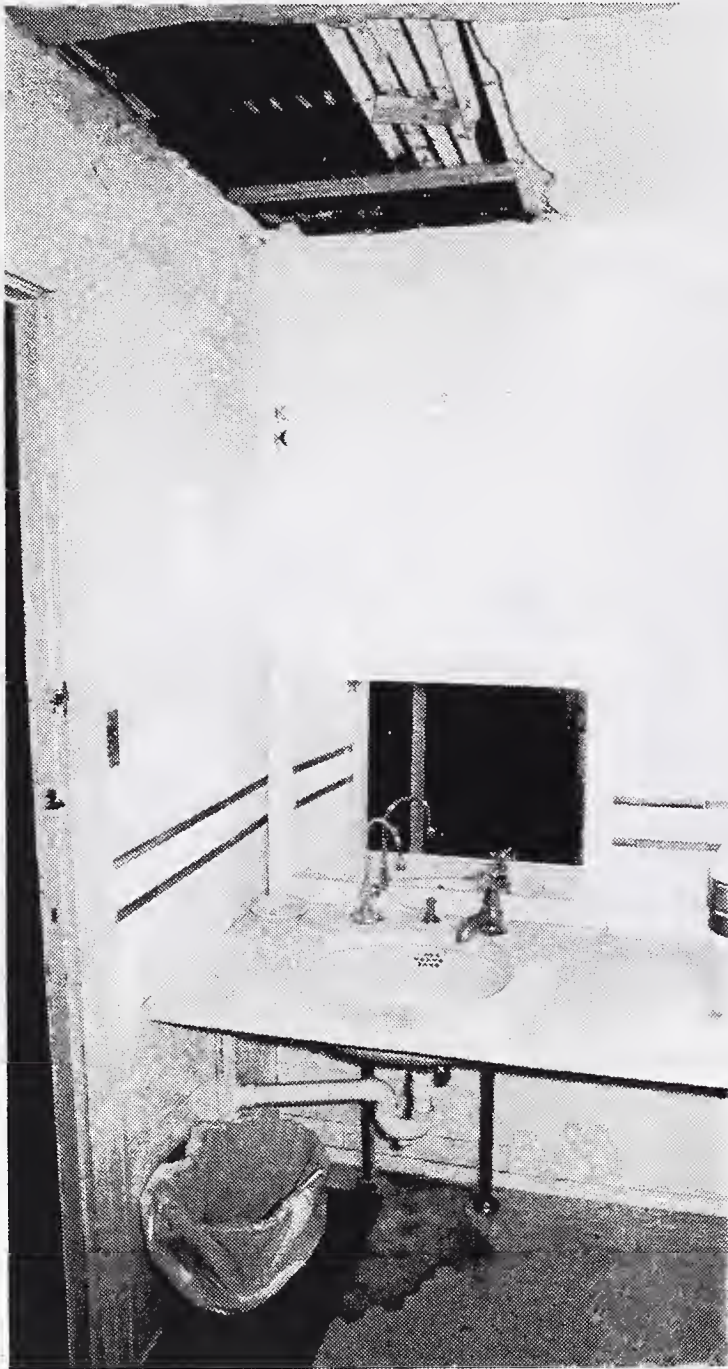
Figure 36. Original Sink and Tiles with Water Damage Above at Room 204.

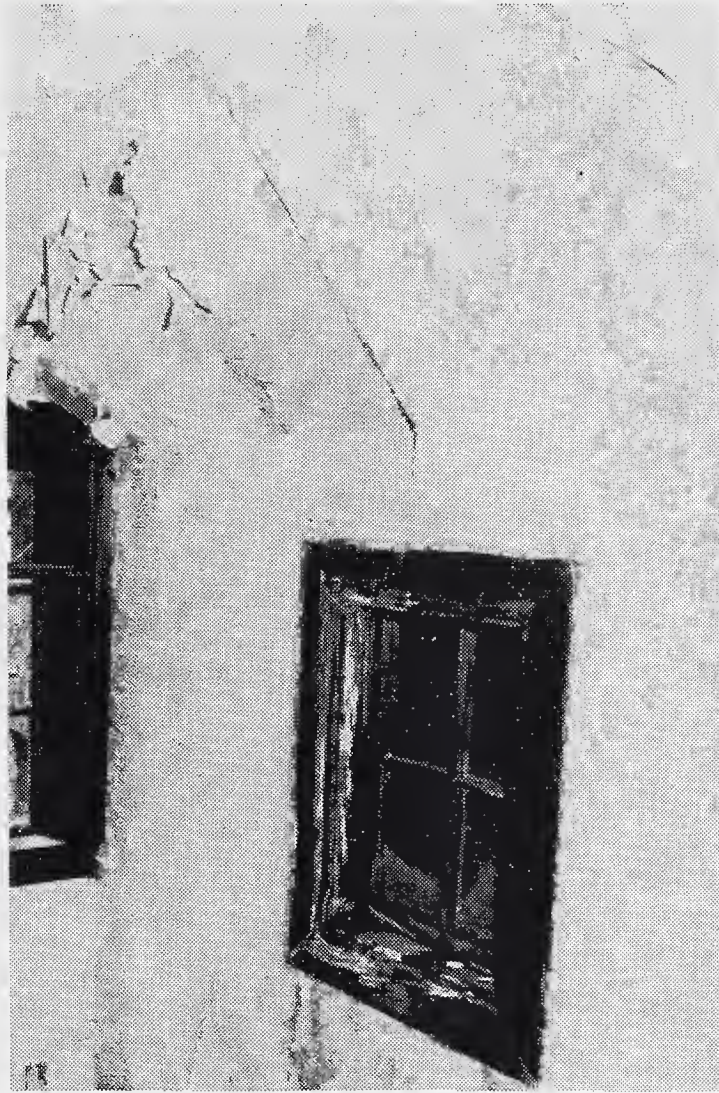
Figure 37. Plaster Damage from Defective Dormer Flashing.
Typical Wood Trim in Room 221.

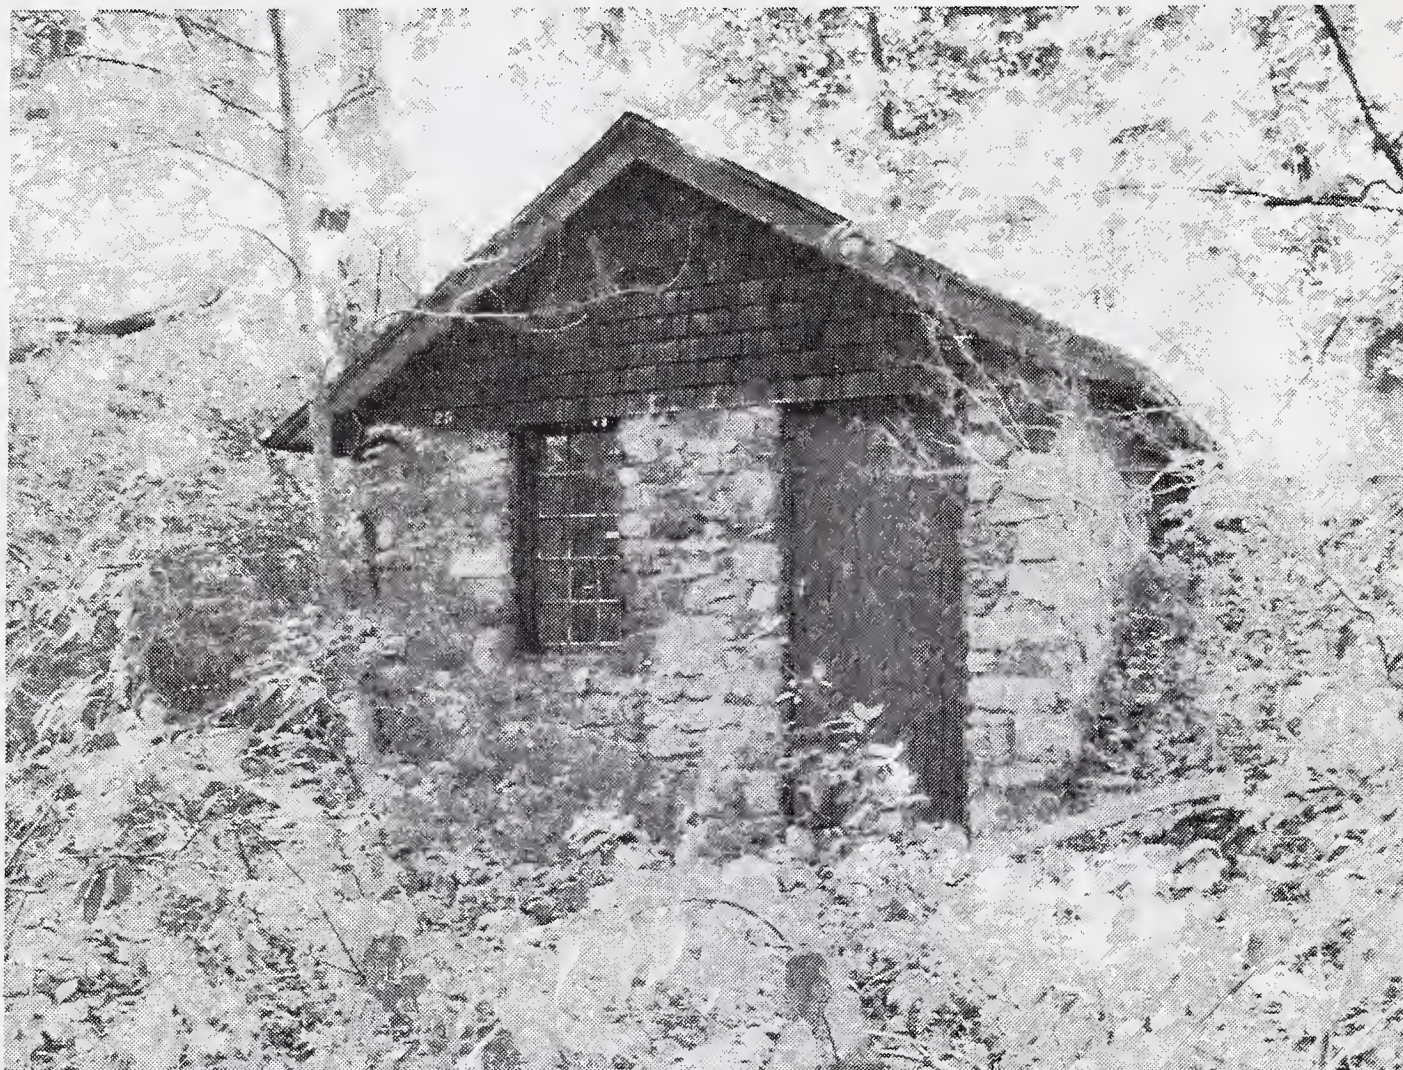
Pumphouse. The front of the pumphouse is a full story high while the back is completely below grade (Figure 38). The earth slopes upward from front to rear along the side walls. The walls are cast-in-place concrete below grade and mortared field-stone above grade. Both types of walls are in good condition.

Interior wood walls have been built out from the stonework at the front of the room but stop short of the floor or are rotted and damaged at the ground level.

The attic floor structure is rotted and collapsed. The rafters and sheathing at the front half are locally rotted, especially along the ridge, but the back half is in better condition, being somewhat newer and not original. The rafter tails and edges of the eaves at the back of the roof are covered by ground, as is the bottom of the gable wall at the back. As one would expect, the wood in contact with the ground is extensively rotted. Elsewhere on the roof, shingles are torn and missing, revealing the sheathing underneath. Vines and tree branches also cover the roofing.
